# Classification, Effects, and Prevention of Build Defects in Powder-bed Fusion Printed Inconel 718

Prepared By: Arthur Brown

NASA

Marshall Space Flight Center

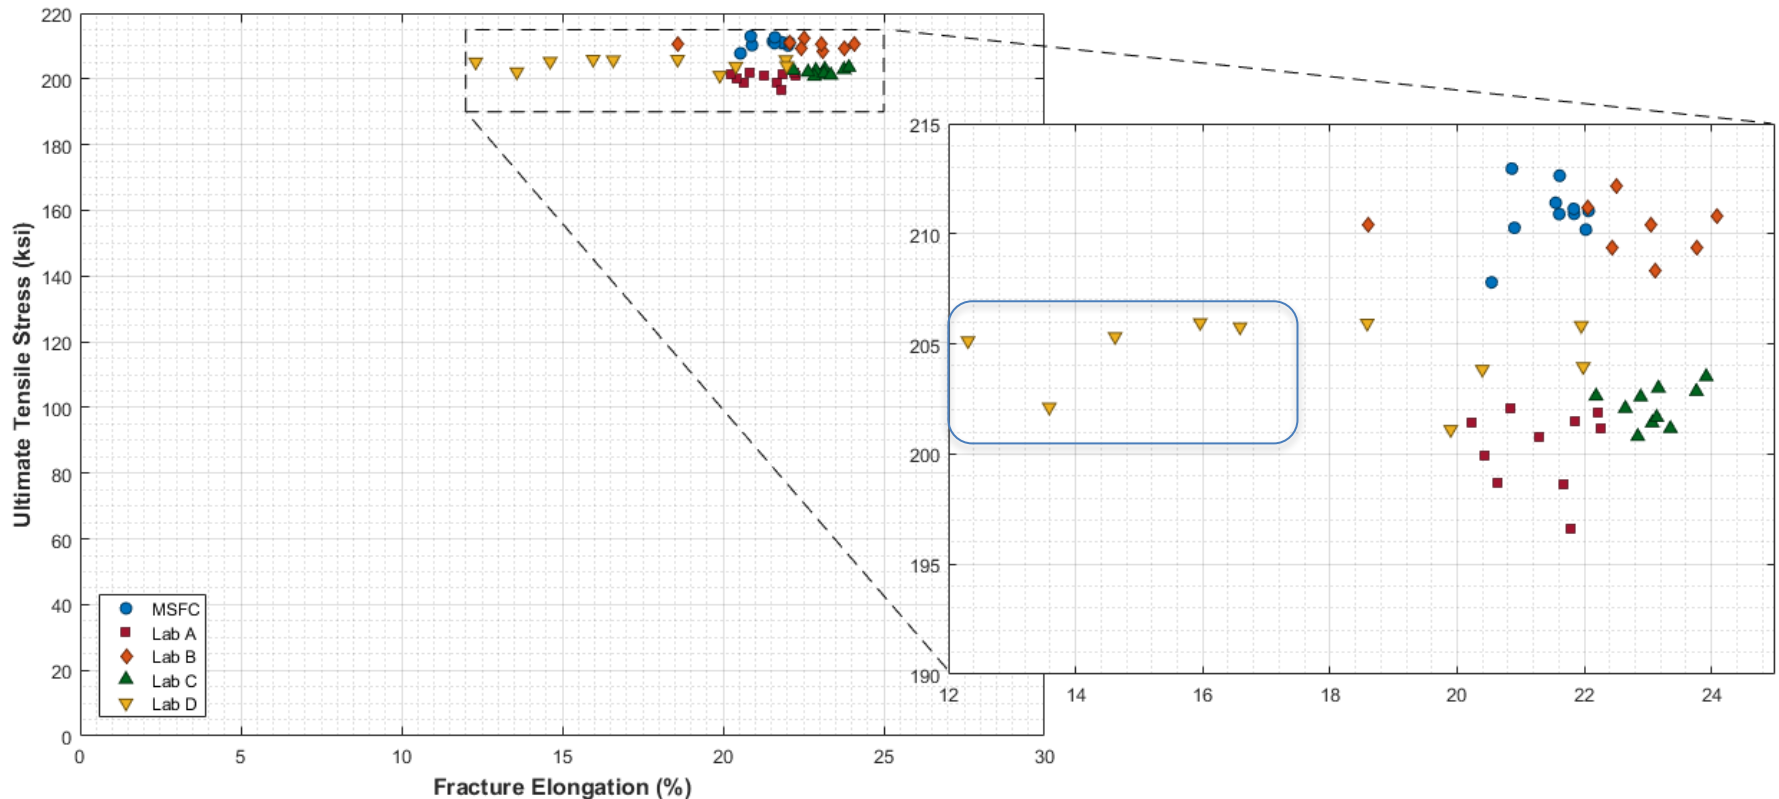
- At room temperature, most builds exhibited tightly grouped results, with the exception of Lab D, which has considerable variability in ductility (fracture elongation).
- From past experience, lower elongation is an indication that defects were present in the material.

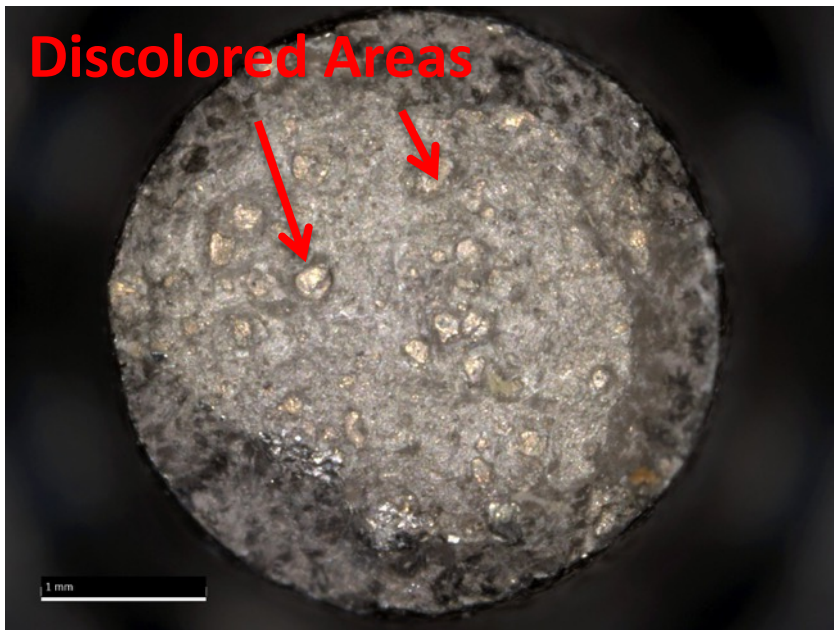
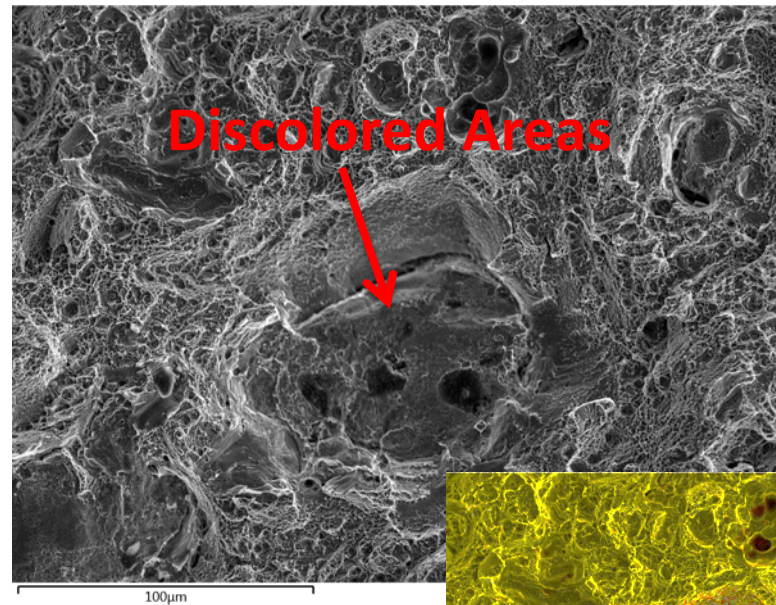
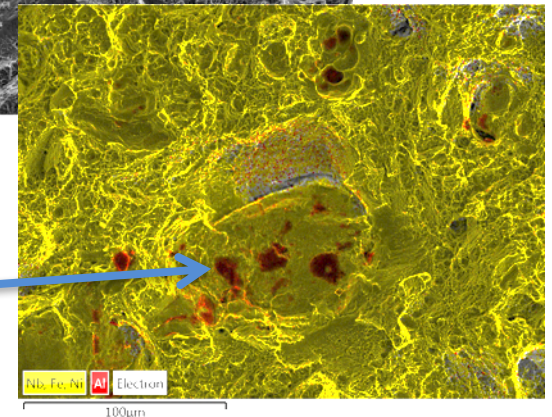
- Optical examination of the fracture surfaces of Lab D specimens show numerous discolored on the fracture surfaces.
- EDS mapping of these areas show that these areas are oxidized.
- It is clear that the elongation results from Lab D underperformed due to lack of fusion defects.

EDS show  
presence of  
Aluminum Oxide

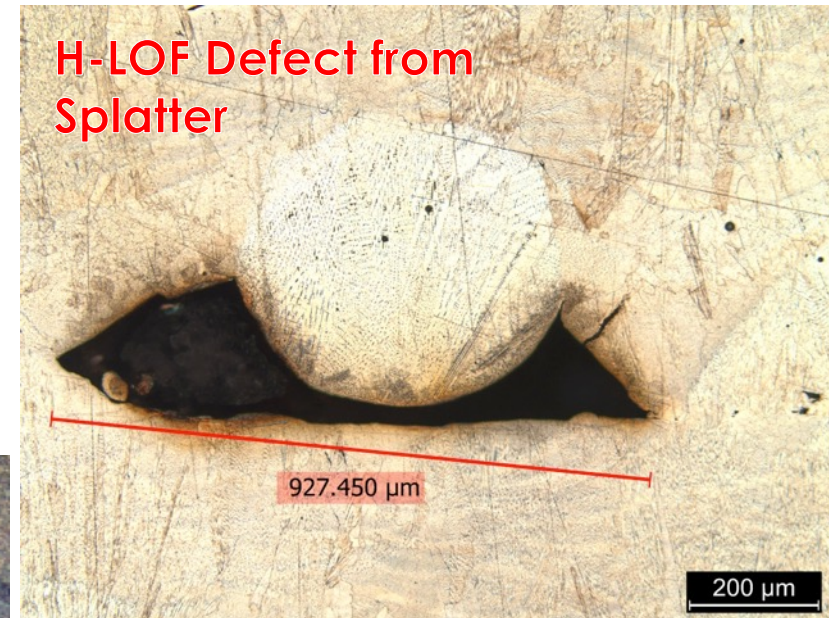
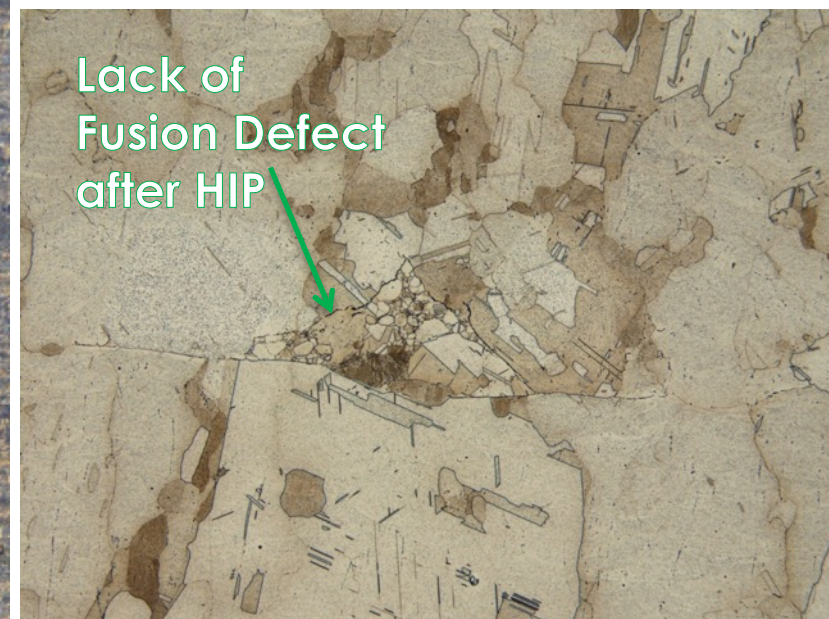
- Horizontal Lack of Fusion Defects are generated in several ways:
  - Low power/high speed settings.
  - An attenuated laser.
  - Splatter falling on surface.
- This type of defect is considered detrimental to mechanical properties.

**H-LOF Defect from Laser Attenuation or Low Energy Density**

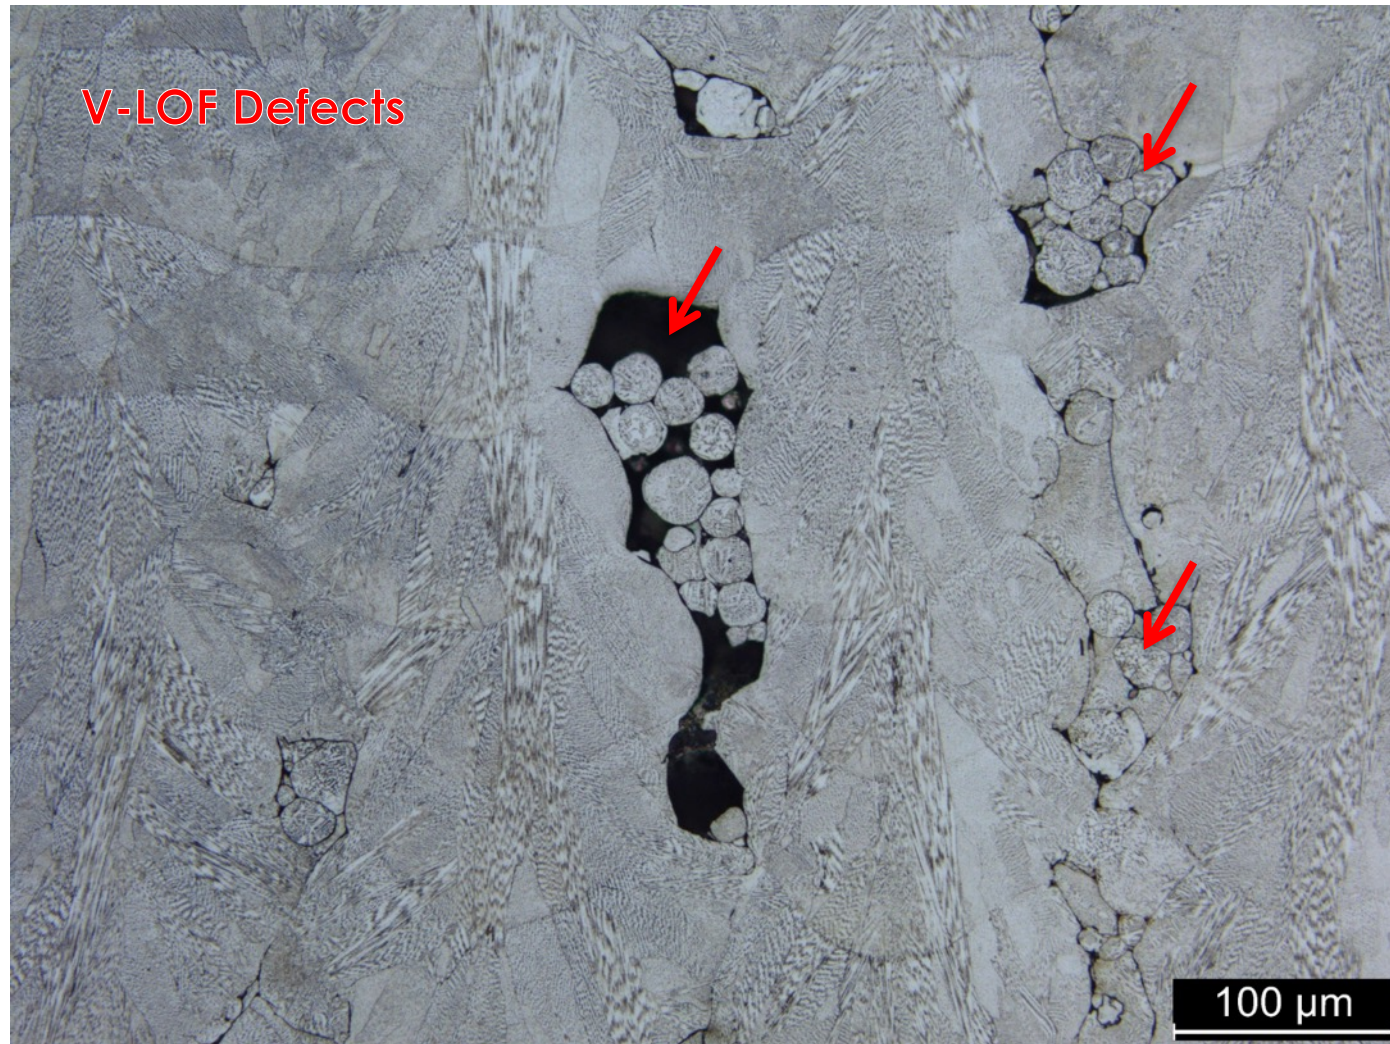
- Vertical Lack of Fusion Defects occur when the hatch spacing parameter is too wide.

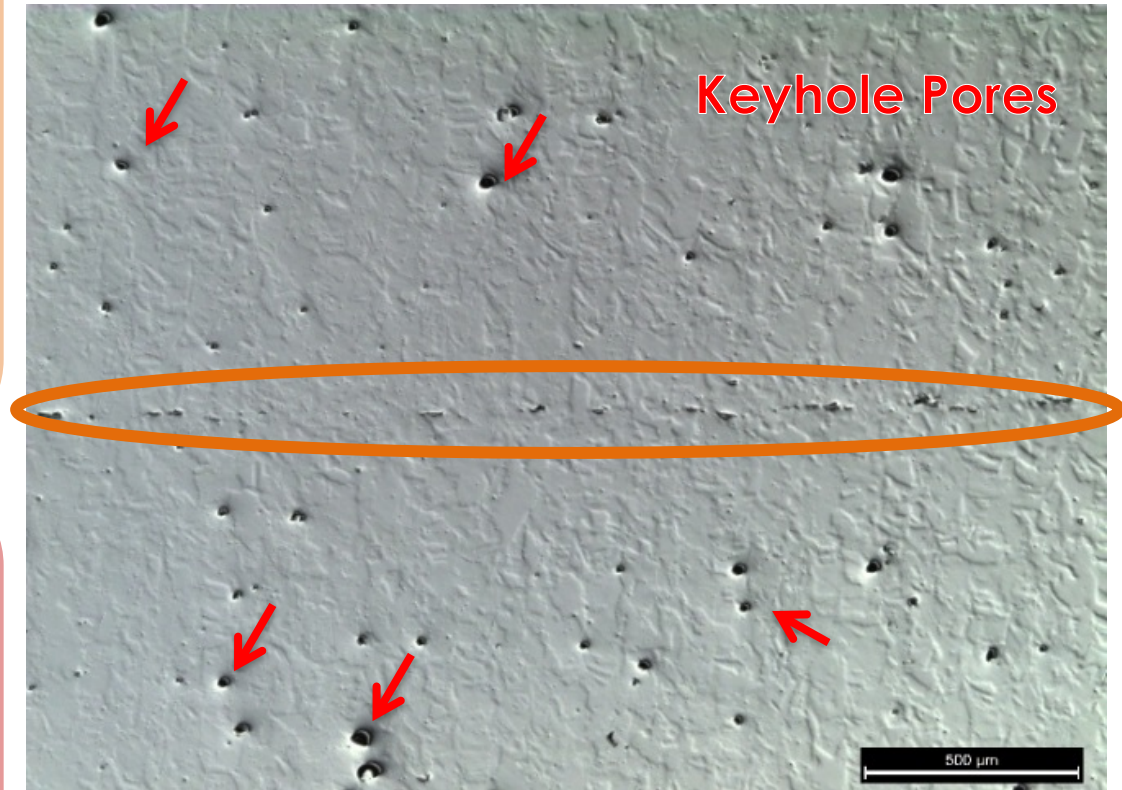
Short Feed Defect occur when there is not a sufficient amount of powder to cover the powder bed.

When enough powder is eventually supplied some number of layers later, the layer is too thick for the laser to penetrate completely.

Spherical porosity occurs when the energy density of the laser is high enough to generate a “keyhole” melt pools. Although we develop parameters to achieve 100% density, this porosity generally “heals” in the HIP and we do not have data on their effect on mechanical properties.

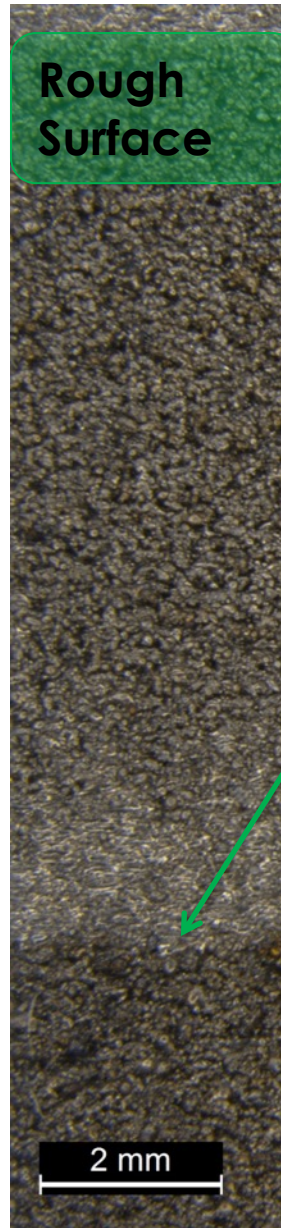
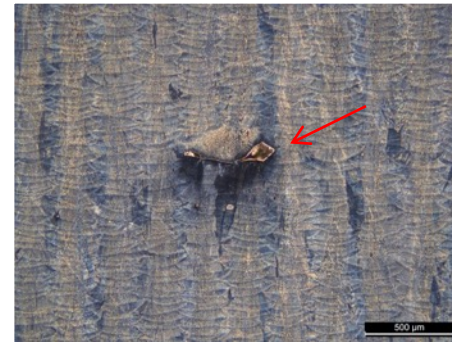
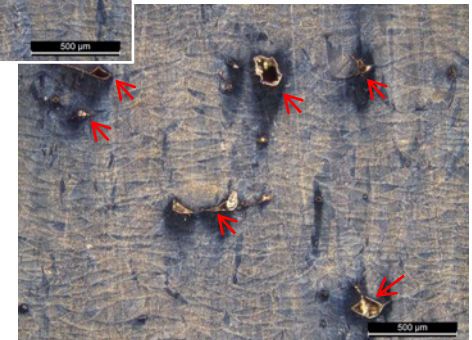
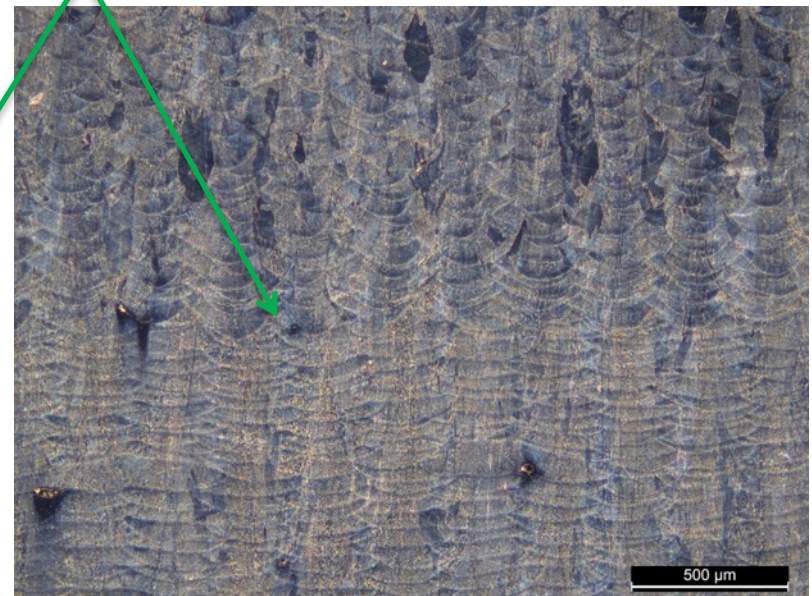
- During a build with a large of cross sectional areas, discoloration of the top surface was observed.
- This discoloration went away when the lens was cleaned during a build stoppage.
- Upon completion, it was observed that there was a gradual degradation of the surface roughness that also went away when the lens was cleaned.
- Subsequent microscopy of the specimens from this build revealed that the areas where the surface was rough contained lack of fusion defects and generally displayed shallow melt pools.
- It was clear that soot and fine particulate ejected from the build process was being deposited on the lens.
- This attenuated the laser—effectively reducing the power density.

**Lens Cleaning**

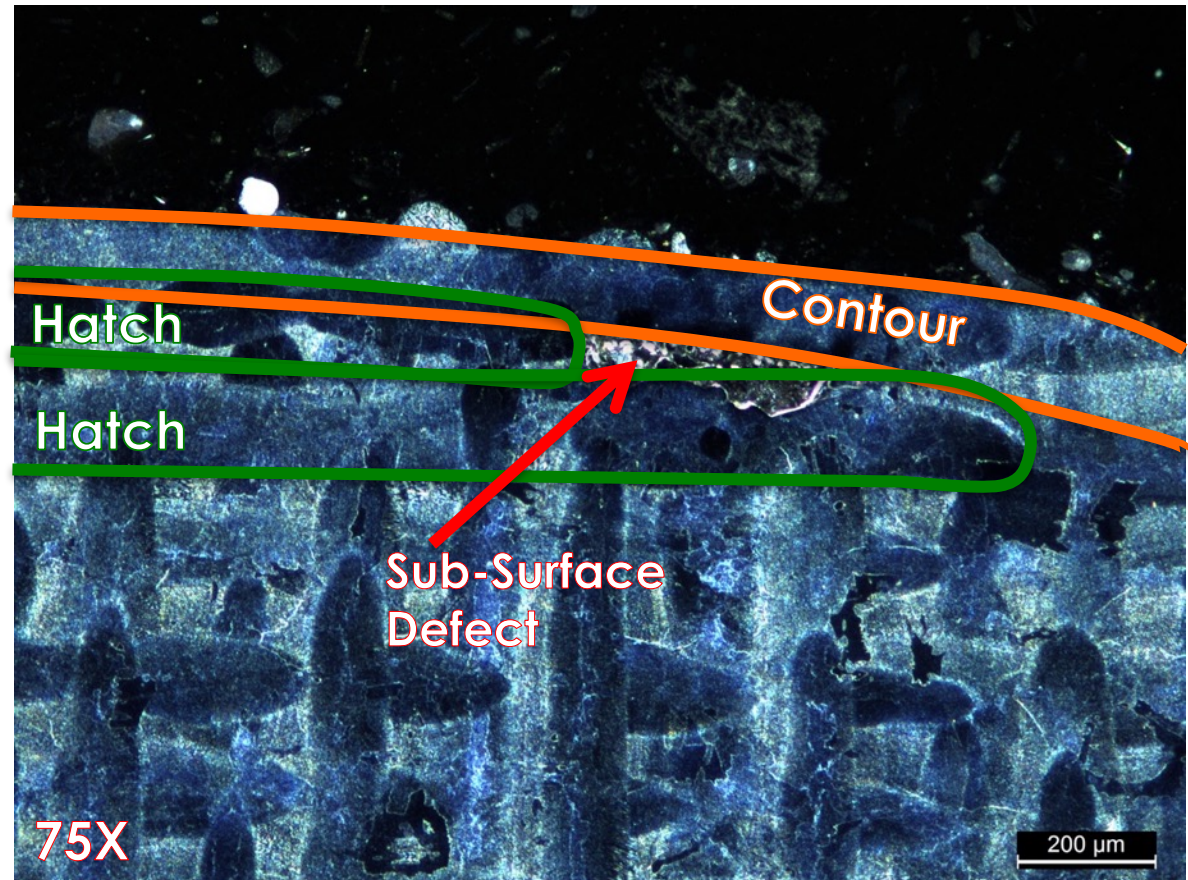
- Sub-Surface defects are created when the offset is too large.
- These defect will not "heal" during the HIP Process.
- During HT the free surfaces of these defects will oxidize.
- This creates fatigue initiation sites that reduce HCF life.

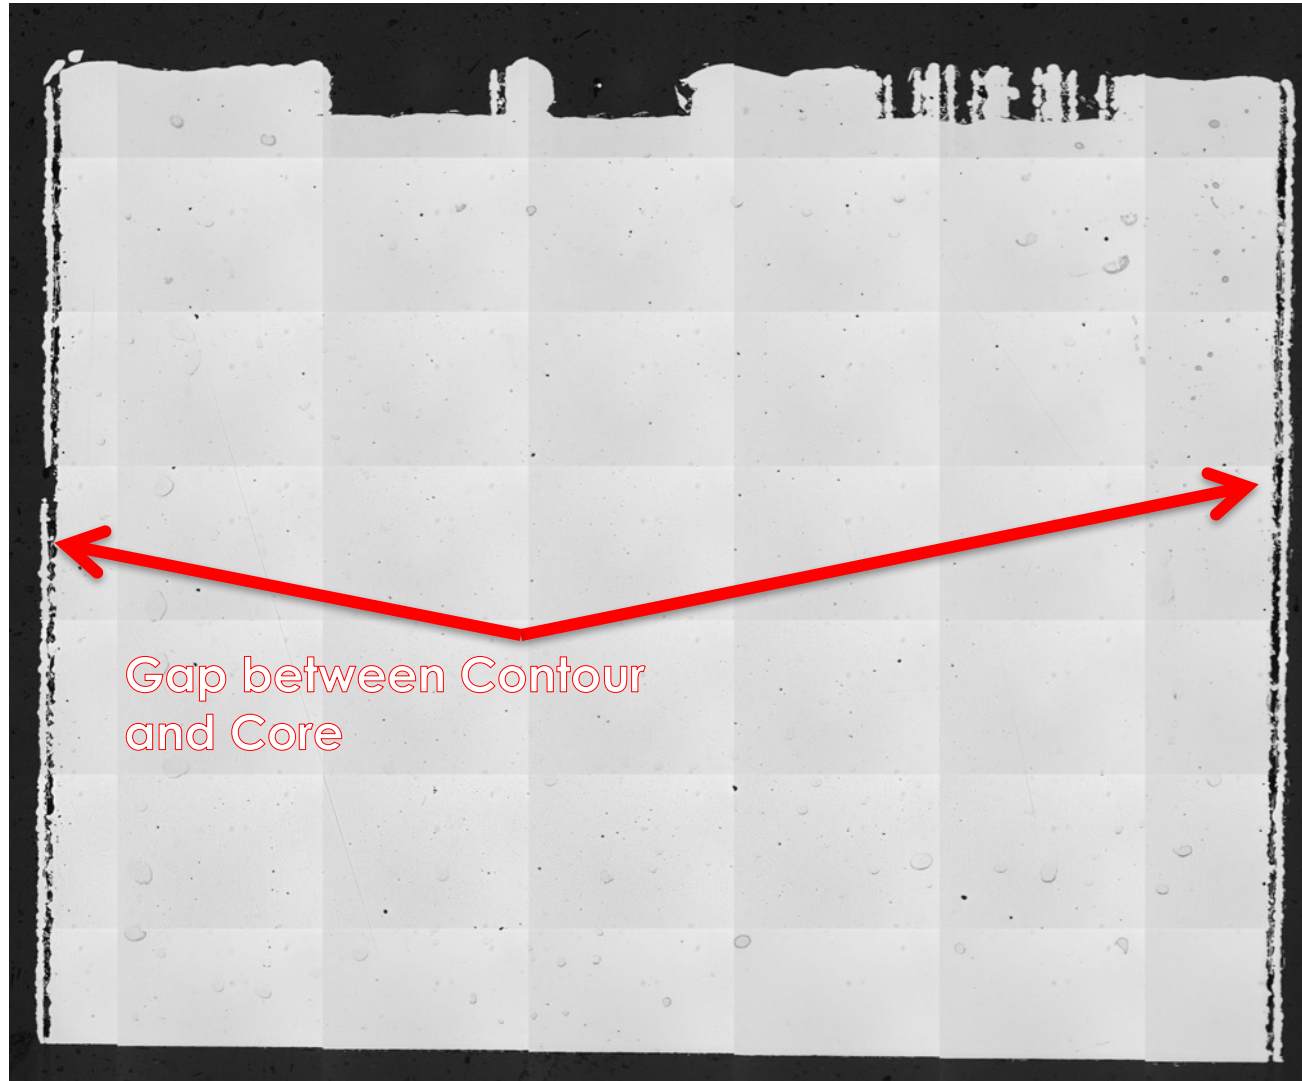
- Detached Contours occur when the offset is too large.
- These usually result in parts with superior surface finish, but the defect is undesirable for obvious reasons.

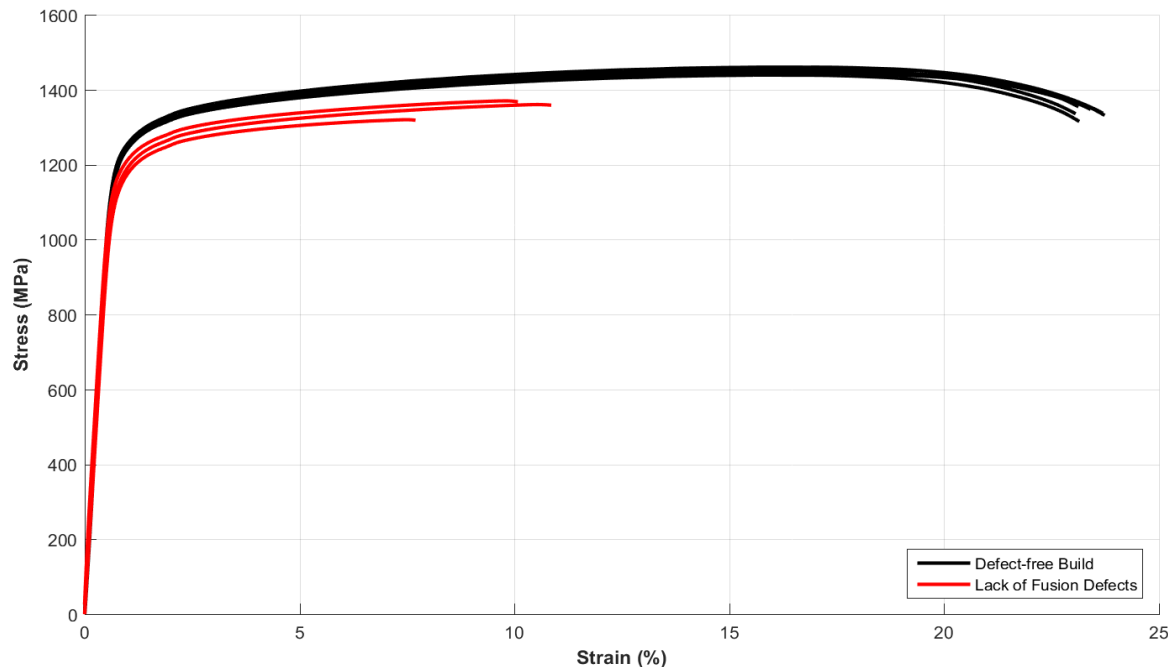
- H-LOF defects result lower than expected tensile properties.
- There is a noted drop in the elongation of material with these defects.

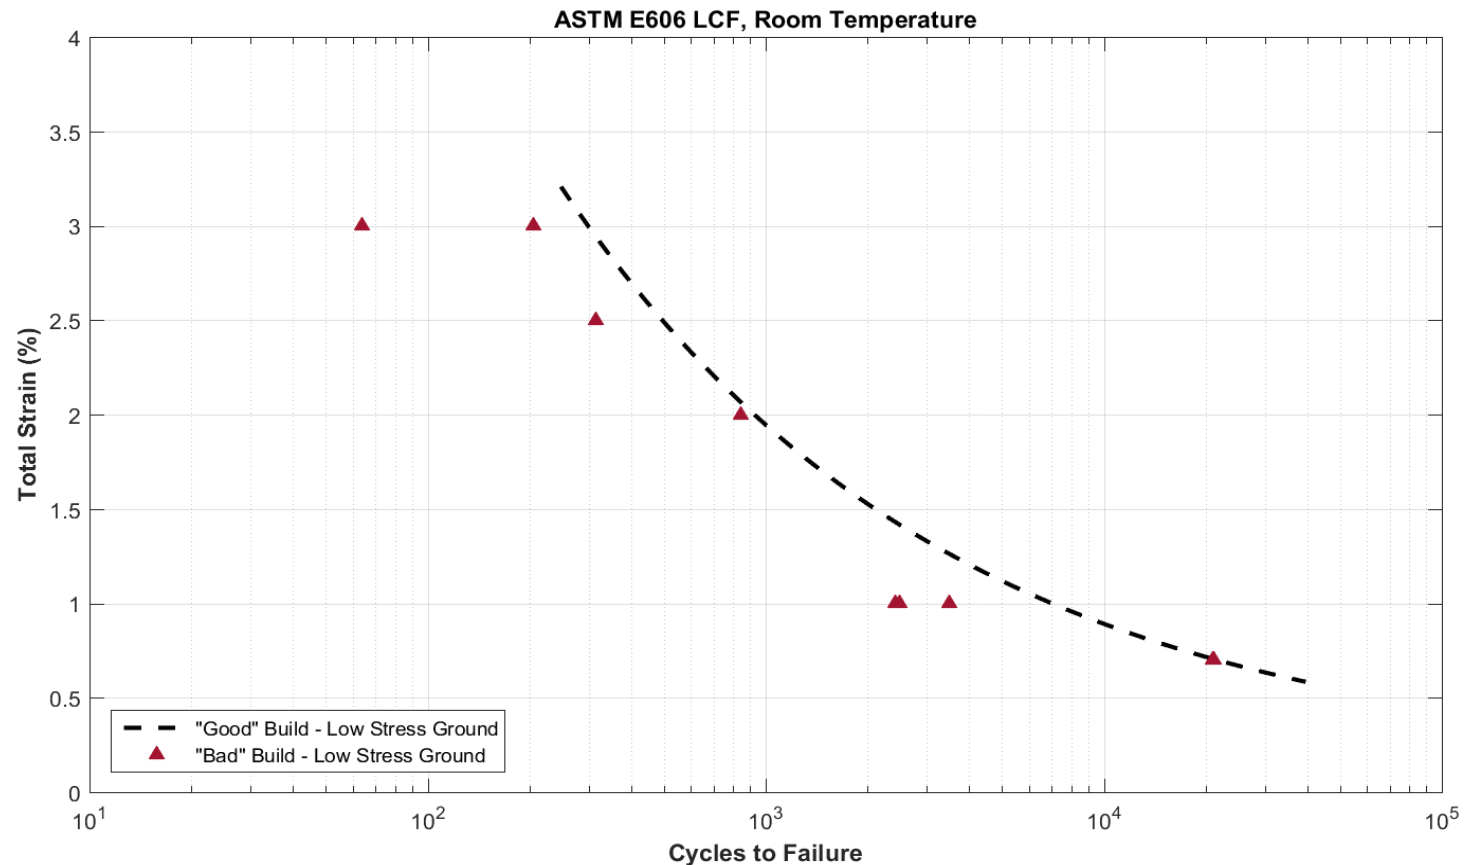
- H-L0F defects also reduce Low-Cycle Fatigue Life.
